Impala SS / Caprice Brake Bolt Modifications

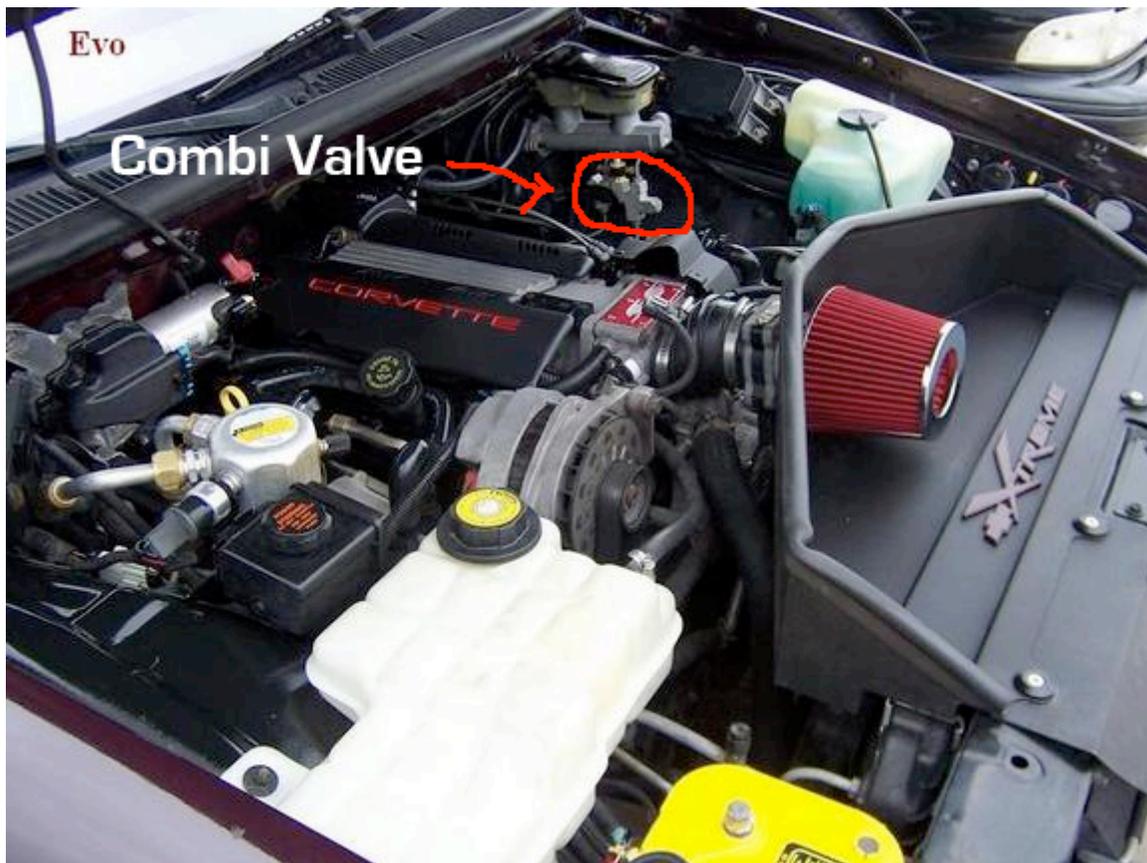
The combination valve in the Impala SS / Caprice (pictured above) performs the following functions:

1. Front/rear brake bias (also called proportioning)
2. Metering (delay) of front brakes
3. Shuttle switch for hydraulic failure of front or rear brakes.

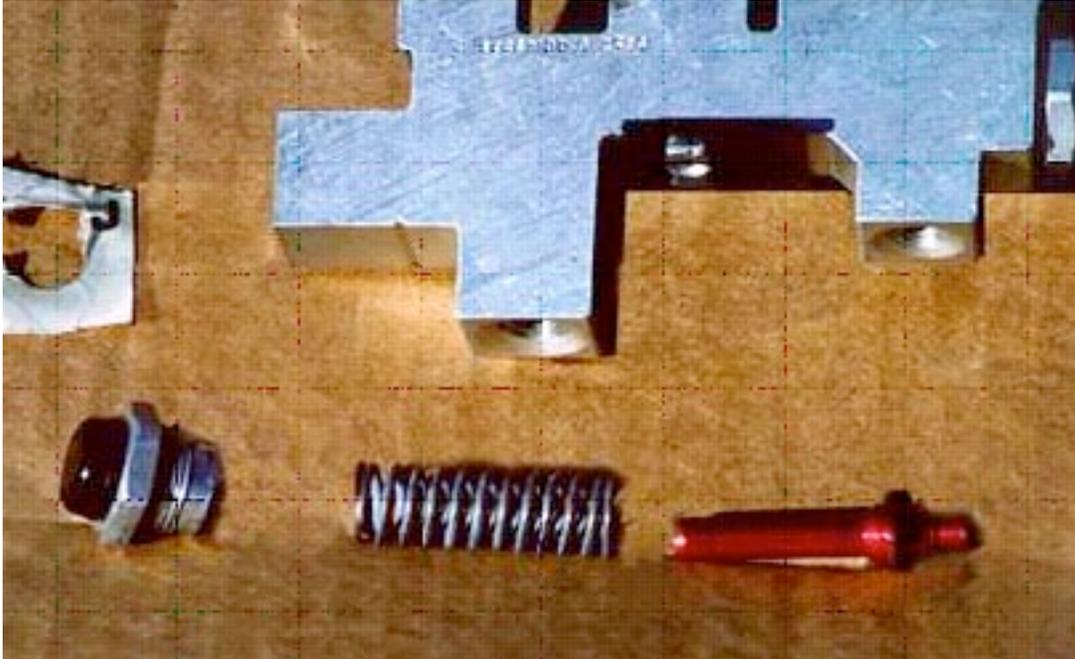
Fortunately for all of us Impala SS / Caprice 9C1 owners, there are solutions for these two problems. The Proportioning problem (problem #1 above) is solved by replacing the stock 19mm hex bolt on the front of the combi valve with a nifty little piece called the Stealth Brake Bolt. The stock bolt is vented and holds a spring and red aluminum plunger in place (see below). The Stealth Brake Bolt replaces the stock vented bolt and the spring and red aluminum plunger are discarded. It's that simple - after that is done, your brakes are now proportioned at approximately 65% front and 35% rear!
